MONITORING OF A BOREHOLE TO DETECT POTENTIAL FUEL CONTAMINATION

Monitoring a borehole after a diesel spill to ensure the aquifer is not contaminated

MS1200-01-SYS – Standard version, 4-20mA and relay output

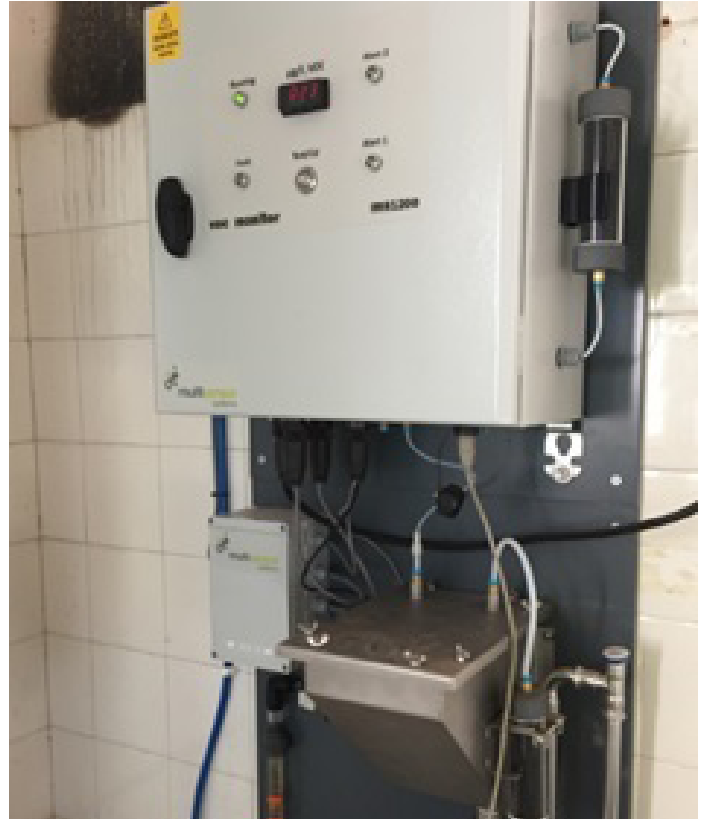
A picture of the unit installed in an outbuilding next to the borehole.

After the spill, the area was isolated with a barrier and the water company wanted to be sure that no diesel had reached the aquifer. A few months after the installation, the system started to give high readings of VOCs, however, no diesel was found. After extensive research, two specific solvents were identified in the aquifer. An investigation is currently underway to find the source of the contamination. The water from this aquifer is no longer used to supply the water plant and the company has avoided sending contaminated water into its network.
