Monitoring of a borehole to detect potential fuel contamination

Sector: Borehole Monitoring

Application: Monitoring a borehole after a diesel spill to ensure the aquifer is not contaminated

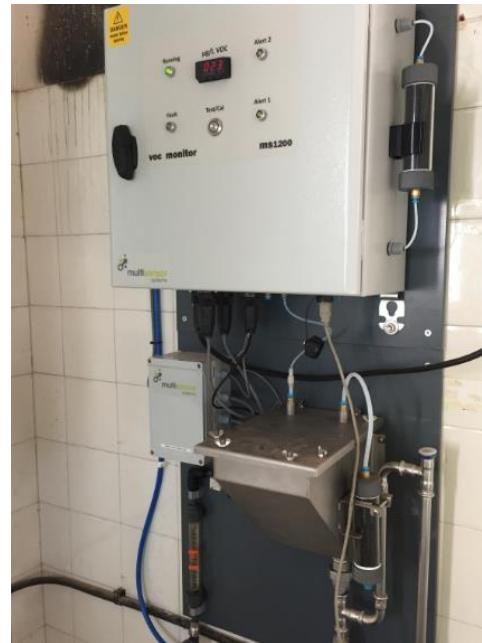
A picture of the unit installed in an outbuilding next to the borehole.

After the spill, the area was isolated with a barrier and the water company wanted to be sure that no diesel had reached the aquifer. A few months after the installation, the system started to give high readings of VOCs, however, no diesel was found. After extensive research, two specific solvents were identified in the aquifer. An investigation is currently underway to find the source of the contamination. The water from this aquifer is no longer used to supply the water plant and the company has avoided sending contaminated water into its network
