MS1200 Oil in Water Monitor Protects Water Treatment Plant from Spill

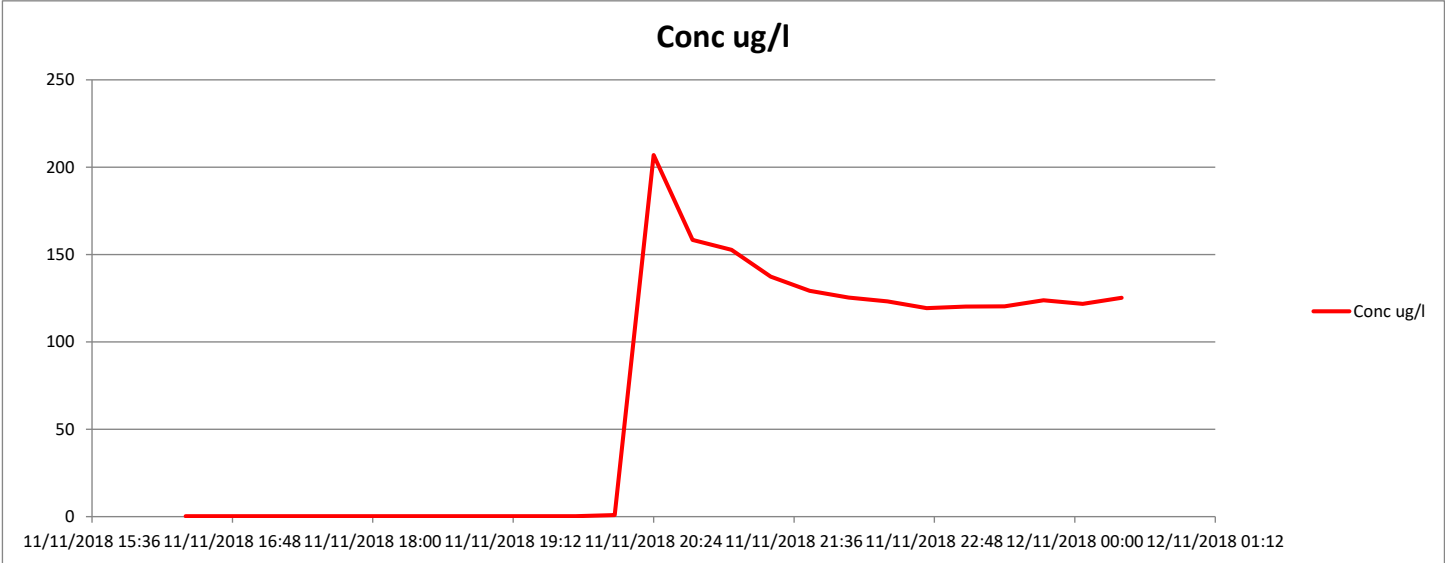
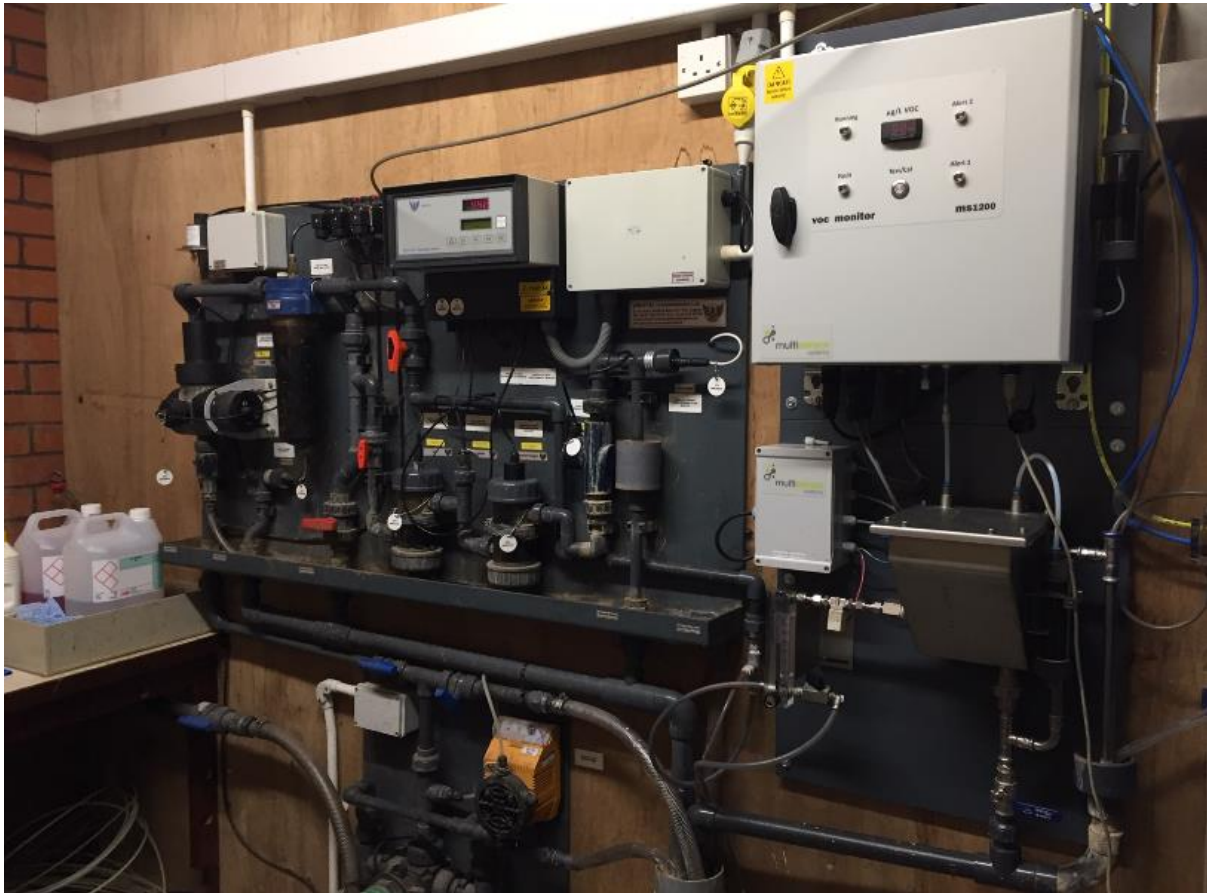
The response of the system is shown below. The level would have continued to rise had the pumps not been turned off quickly.

The MS1200 is connected directly to a bank of relays which switched off the pumps.
